# Manhole Inspection Summary

Manhole # S01EE2034MH

Insp Date: **7/21/06 6:44 AM**

**Location** Address: **6306 BENHURST RD**

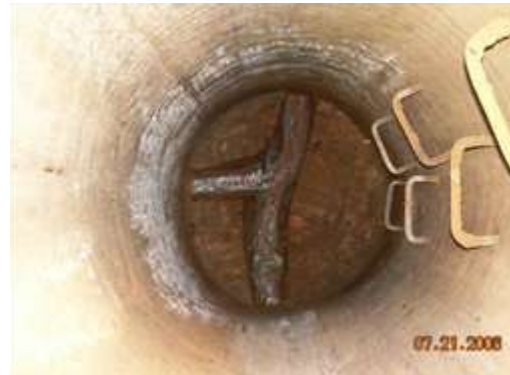
Top View

Adjustment and Corbel infiltration.  
Evidence of surcharge - Bench debris.

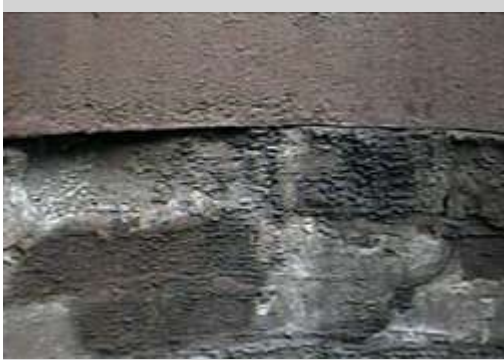
Defect

Frame leaks. Adjustment deterioration  
and infiltration.

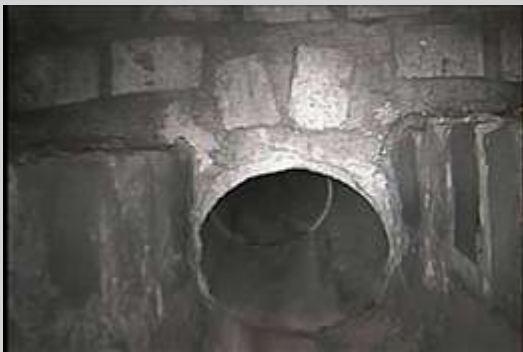
### 8 in. Circular Gravity Sewer Pipe Out @ 12 O'Clock

Infiltration: **Evidence** Pipe Seal Cond: **Cracked**
